## TMDL Assessment Summary

# Kimball Brook

This **TMDL** assessment summary applies to Kimball Brook, a 1.55-mile stream in the City of South Portland, Maine. Kimball Brook is a small tributary to Trout Brook (Mill Creek), which empties into Casco Bay in South Portland. Kimball Brook begins in a wetland area just south of Highland Avenue in South Portland. The stream flows parallel to Highland Avenue through several narrow wetland areas. Shortly after it passes under Stillman Street, Kimball Brook flows into one of two consecutive small impoundments. After the second impoundment, Kimball Brook continues under Ocean House Road (ME Route 77) before flowing into Trout Brook near Mill Creek Park in downtown South Portland. The Kimball Brook watershed covers 346 acres in the City of South Portland and the Town of Cape Elizabeth.

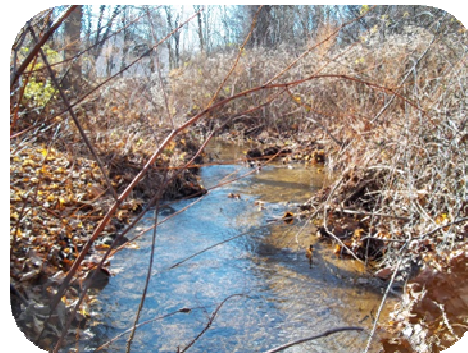
*Kimball Brook upstream of Station 795.  
(Photo: FB Environmental)*

Kimball Brook impairment is based on data collected by DEP in 2005 at the sampling station upstream of Ocean Street (S-795) (DEP, 2010b). Data collected at this station indicated Class C Kimball Brook is “non attaining” (NA), meaning it does not meet Class A, B, or C conditions.
