# Subject:Island Road Vulnerability Assessment, South Thomaston, Maine<br/>Penobscot Bay Working Waterfront Resiliency Analysis<br/>State of Maine, Department of Marine Resources

Island Road Vulnerability Assessment, South Thomaston, Maine Penobscot Bay Working Waterfront Resiliency Analysis Maine Department of Marine Resources

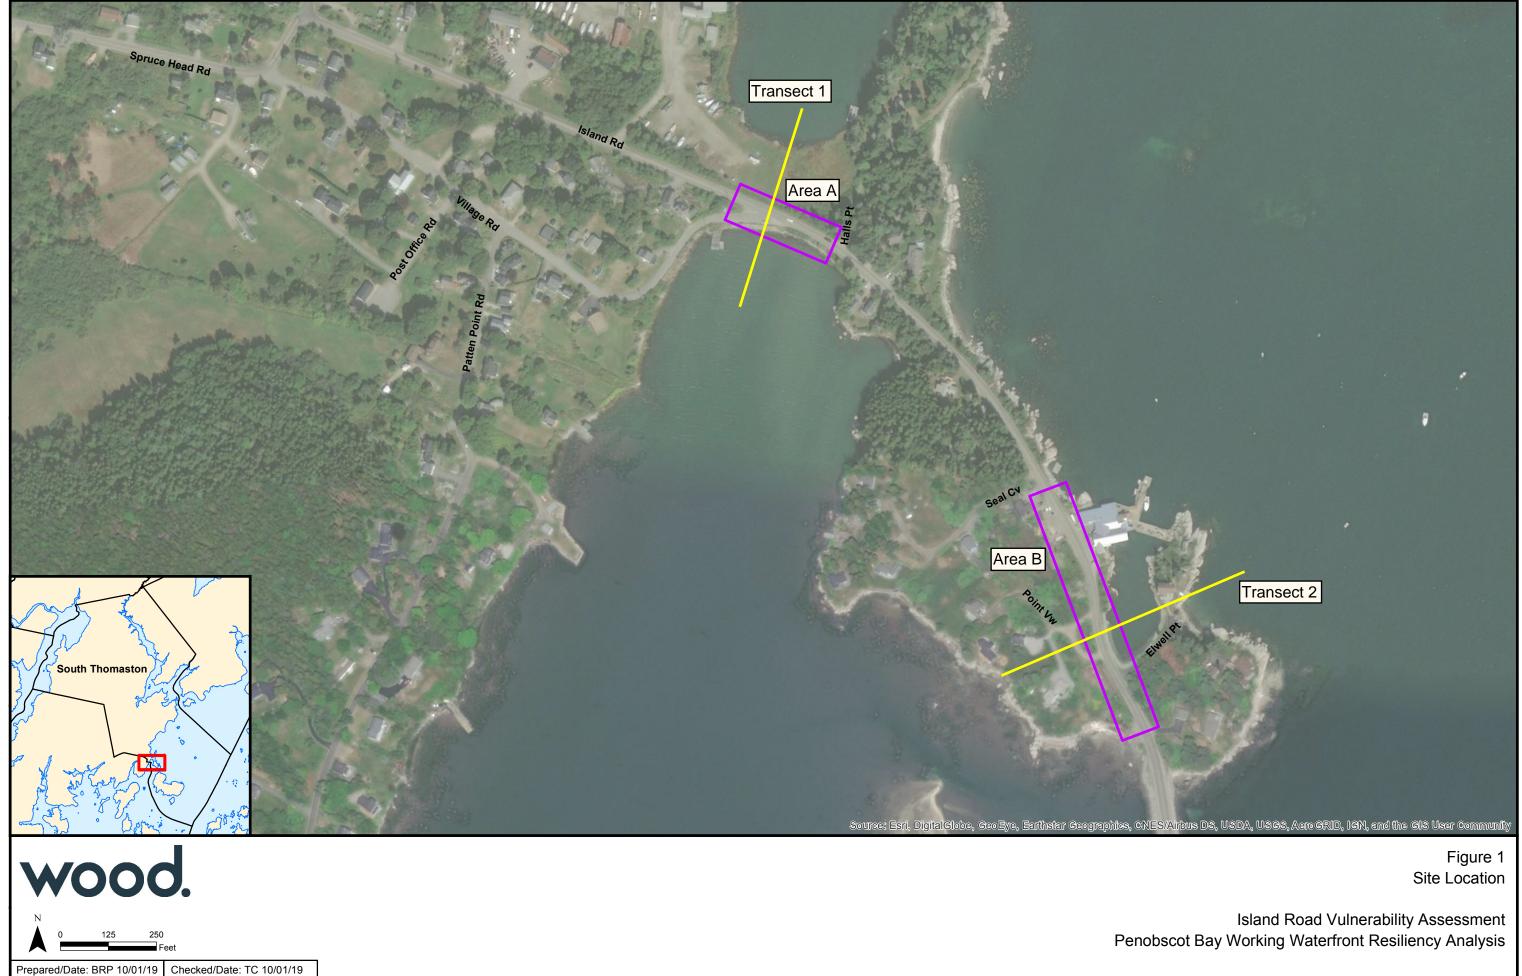
| Attachments: | Key Definitions and Abbreviations | | |
|---|---|---|--|
| | Figure 1 | Site Location | |

Wood's original scope of work for DMR's Penobscot Bay Working Waterfront Resiliency Analysis Project included an assessment of the causeway between Spruce Head and Spruce Head Island in South Thomaston, Maine relative to vulnerability to flooding under various flood and sea level rise (SLR) scenarios. At the request of the Town, DMR requested that Wood alter the scope of work to accommodate an evaluation of the vulnerability of Island Road which extends between Spruce Head and causeway to Spruce Head Island (**Figure 1**). The focus of the evaluation includes:

Area A: A low-lying stretch of Island Road just east of Village Road to Hall's Point Road; and

**Area B**: A segment of Island Road between Seal Cove Road and Elwell Point Road; this segment includes a low-lying stretch of Island Road near the entrance to Point View Road and a portion of Island Road which may be realigned near a parking near the entrance of Seal Cove Road.

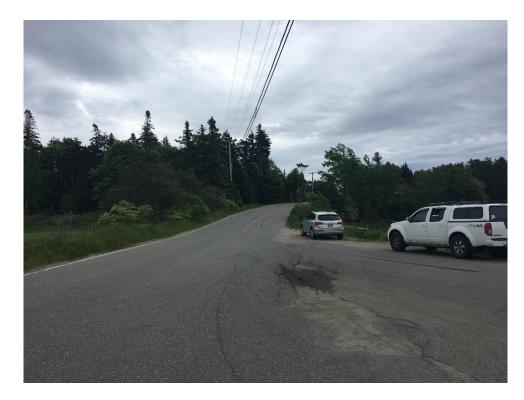
#### PHOTO 1:

Area A - Island Road, view to southeast and rise in elevation from low-lying area at near intersection with Village Road (right side of photo).

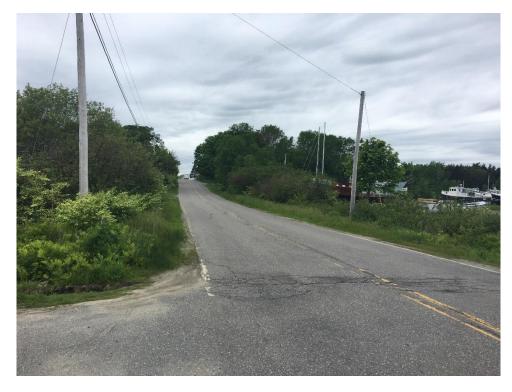
#### PHOTO 2:

Area A - Island Road, view to west and rise in elevation beyond intersection with Village Road (left side of photo).

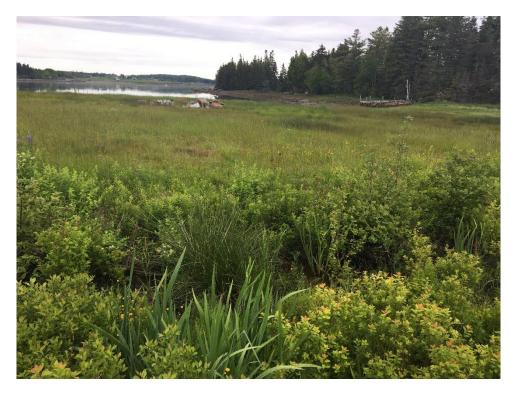
#### PHOTO 3:

Area A – Island Road at intersection with Village Road; note cracks in road leading from reported culvert under Island Road to marsh.

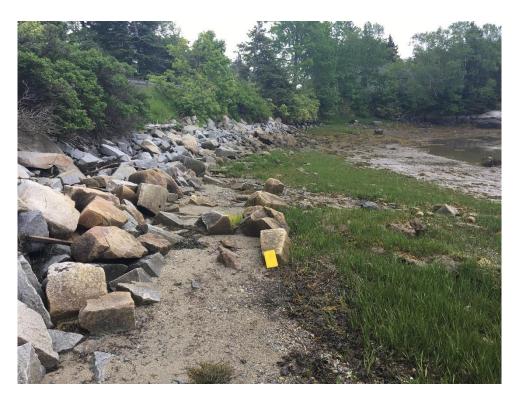
### PHOTO 6:

Area A - Riprap along shoreline south of Island Road; note apparent movement of riprap seaward.

- A geotechnical evaluation of the proposed road reconstruction areas to evaluate the potential settlement and other design considerations; Wood understands the segment of Island Road in Area A is founded on historic fill of unknown character;
- Repair or replacement of road culverts to improve drainage and reduce flooding of Island Road in Area A, and evaluate the benefit of adding road culverts at Area B;
- Raising the roadbed of Island Road at least 3 ft in Area A and 2 ft in Area B to reduced flooding potential for improved resilience through the current and short term scenarios;
- Design and construction of shore protection measures (e.g., riprap) that considers the inundation and wave modelling data and accommodates the long term storm flood scenario to the extent feasible (i.e., wave heights of 3 to 4 ft);

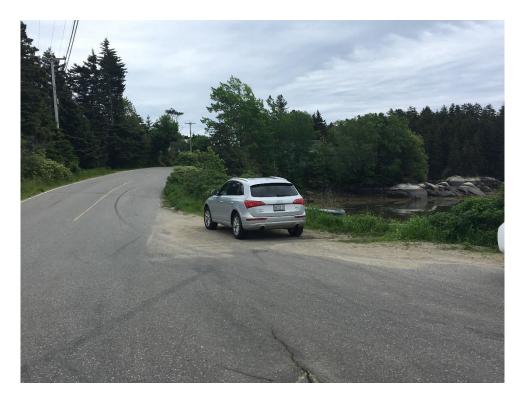
#### PHOTO 7:

Area A - Island Road looking south; note buildup of winter sand in roadway.

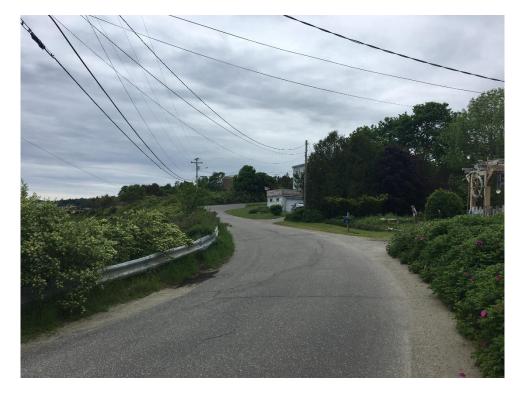
#### **PHOTO 8:**

Area A – Village Road near intersection with Island Road, view to southwest.

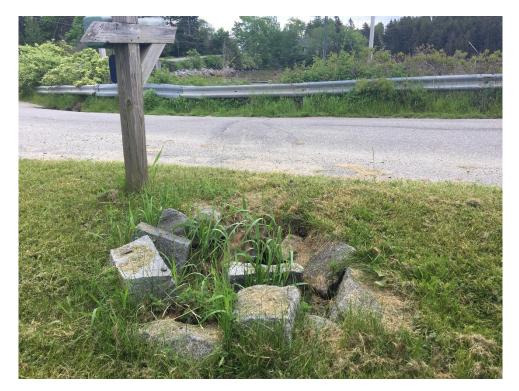
#### **PHOTO 9:**

Area A - Stone at entrance to culvert beneath Village Road, near intersection with Island Road.

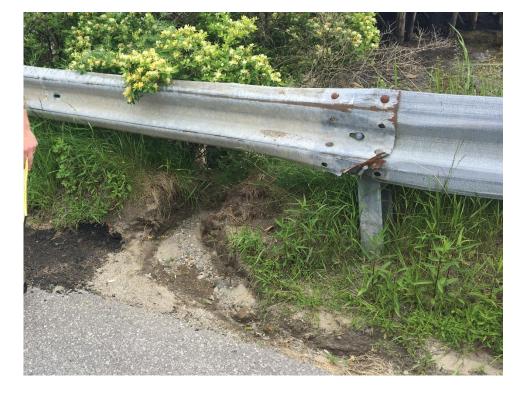
#### **PHOTO 10:**

Area A - Erosion on shore side of Village Road near intersection with Island Road.

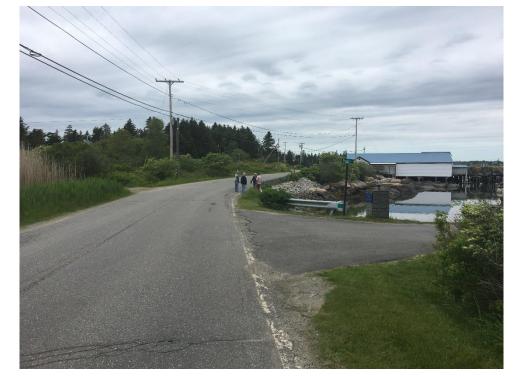
#### **PHOTO 12:**

Area B - Low-lying stretch of Island Road adjacent to clove (former lobster pound) on right side of photo, view to northwest.

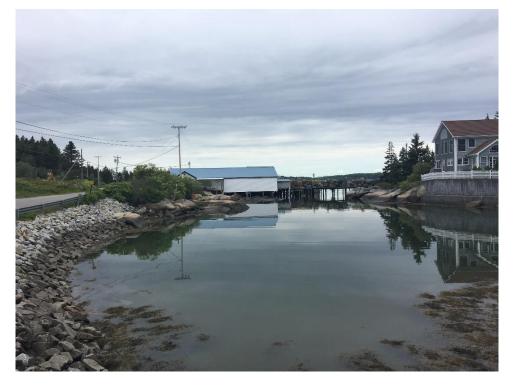
#### **PHOTO 14:**

Area B - Commercial lobster pound and cove; inlet to cove in background, view to the north.

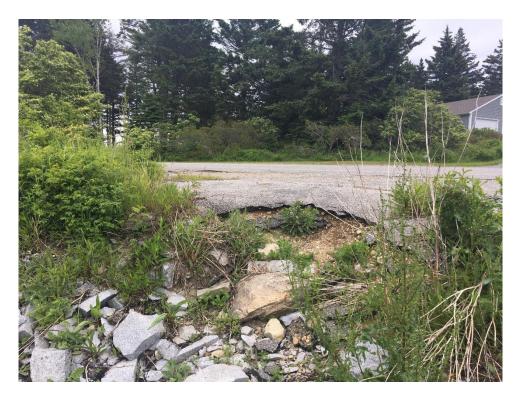
#### **PHOTO 15:**

Area B - Erosion on south edge of Island Road shoulder, near north end of causeway to Spruce Head Island, view to northeast.

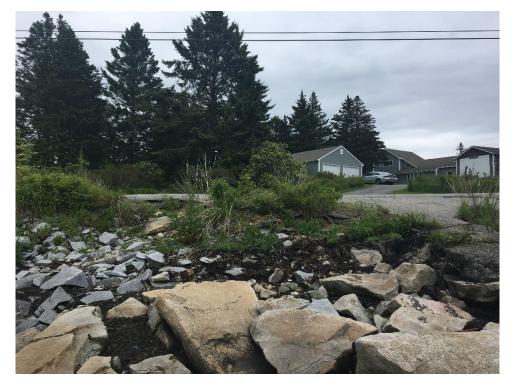
#### **PHOTO 16:**

Area B - Riprap along shore south of Island Road, near north end of causeway to Spruce Head Island, view to northeast.

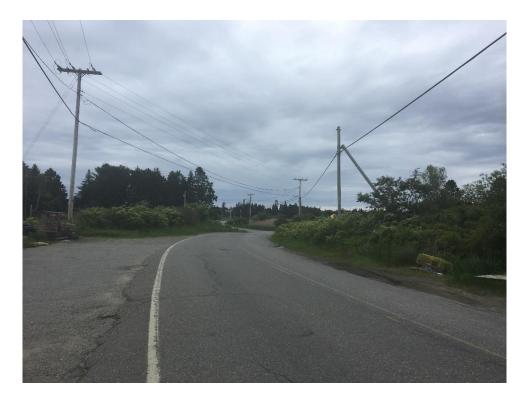
### **PHOTO 17:**

Area B - Curve in road across from lobster pound (left side of photo) proposed for straightening, view to southeast.
